**GAS PIPE LINE AT EASTCHURCH  
ISLE OF SHEPPEY, KENT  
MATTERS RELATING TO TREE HEALTH  
PRELIMINARY REPORT  
OCTOBER 1999**

PBA Consulting  
Bryn Gardens  
Liss  
Hampshire  
GU33 7HB  
01730 893460

**GAS PIPELINE AT EASTCHURCH, ISLE OF SHEPPEY, KENT  
MATTERS RELATING TO TREE HEALTH**

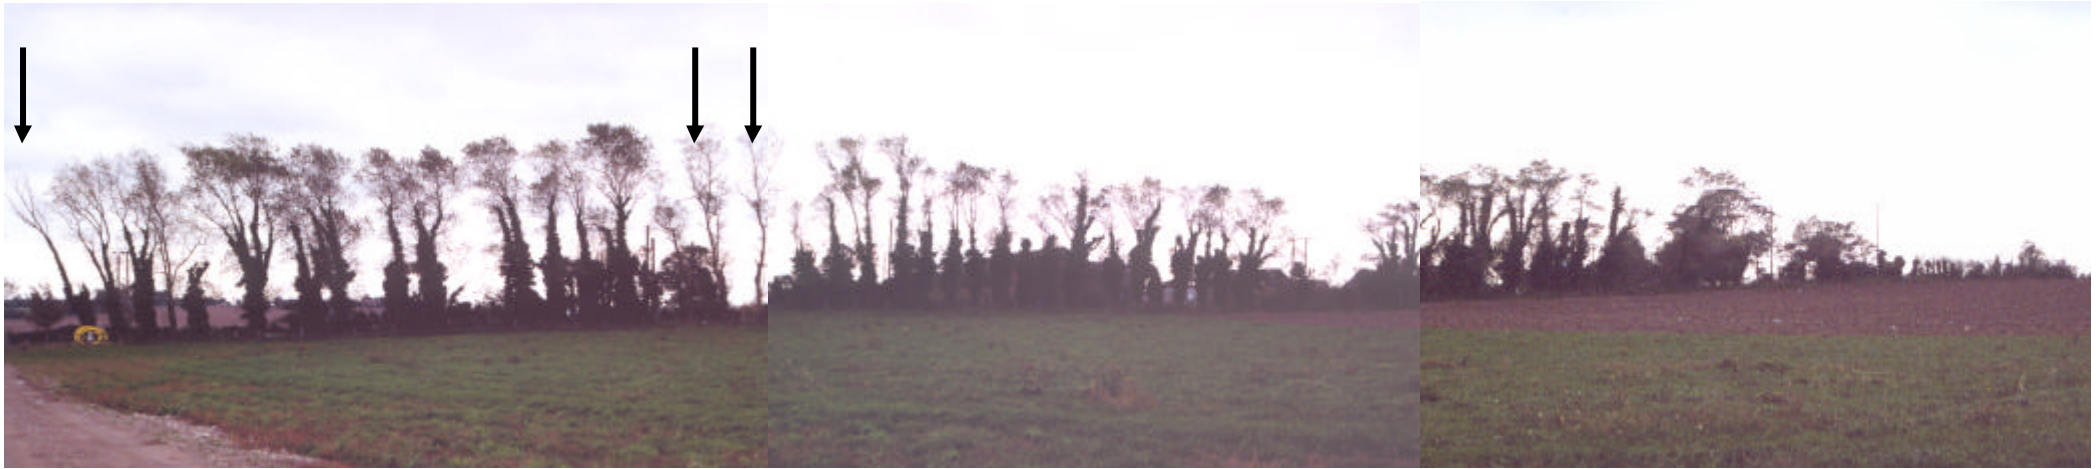
**Photograph No1**

Some 51 trees have been planted in a single row alongside the public highway along a distance of 218m at an average spacing of 4.3m. (See photograph No 1)

There are several gaps in the row of trees and there has been some gapping up with poplar whips (See Photograph No 2). There is a dead tree at the start of the section (One arrow, photograph No 1) and in one area, there are about four trees that have very low vigour (2 arrows, photograph No 1).

Commencing at the eastern end (i.e. from the farm track), the first tree in the row had a large basal cavity and was dead.

Of the fifty-one mature poplars, only five were considered to be affected by disorders that seriously affected vigour or were dead. These were at the east end of the section. The first tree was dead and a cluster of four trees was between 50m and 60m from the start of the section. These trees suffered from low vigour (even of the covering ivy), hollow stems, decay and moth infection.

Photomontage of row of trees with alleged damage  
Dead tree and weak trees shown with arrows

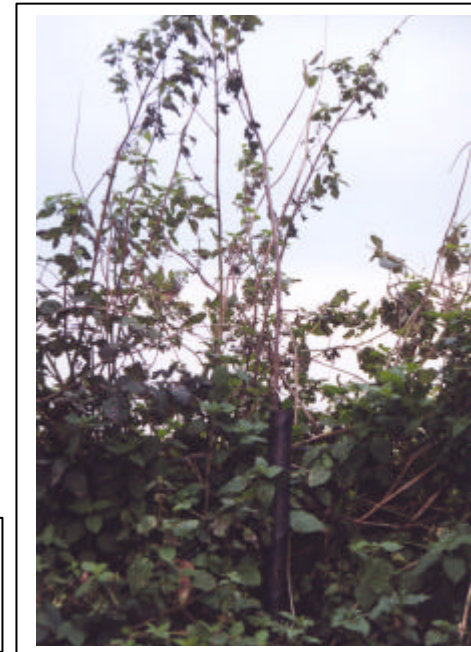
**Photograph No 2**

Whip planting to West of row

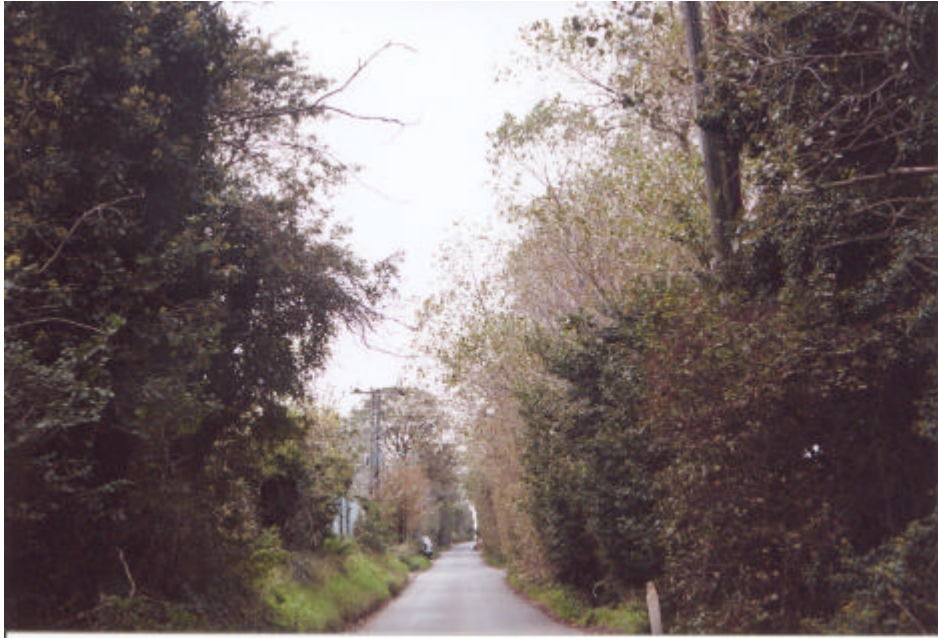
**Photograph No 3**

About mid-way along the row of poplar trees and for the rest of the row westwards, the overhead lines are aligned with the approximate southern part of the tree canopy. Along the full western length, the trees have been lopped so as to remove the southern half of the canopy (See photograph No 3).

Lopping of the south side of trees under power lines

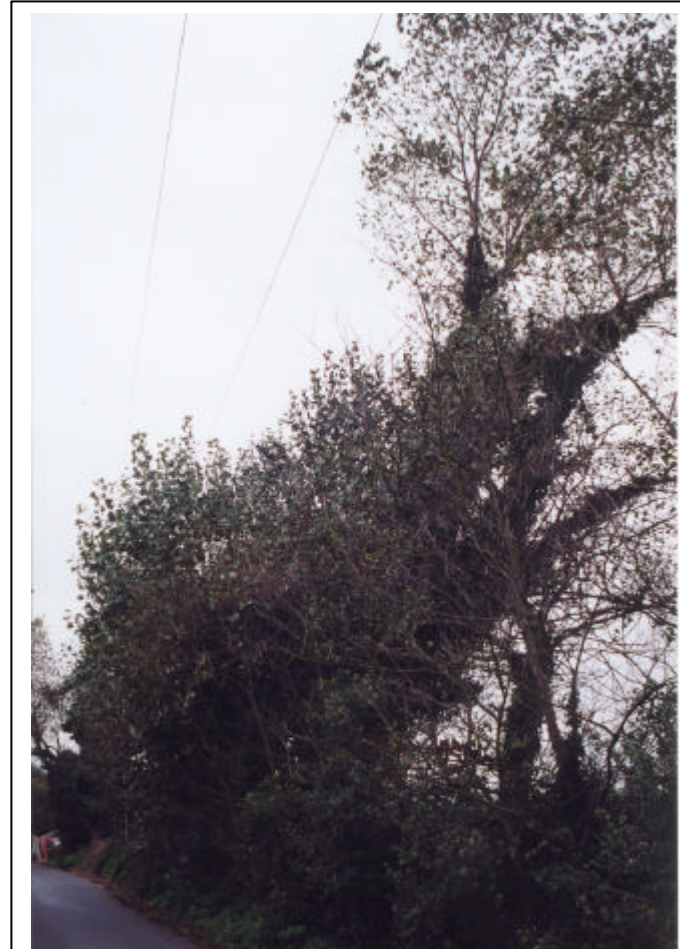
**Photograph No 4**

This lopping and trimming has had least effect in the eastern run of trees but has become severe in the western part where the trees are misshapen in the most affected area (see photograph No 4).

Mis-shaped tree caused by lopping to clear power line

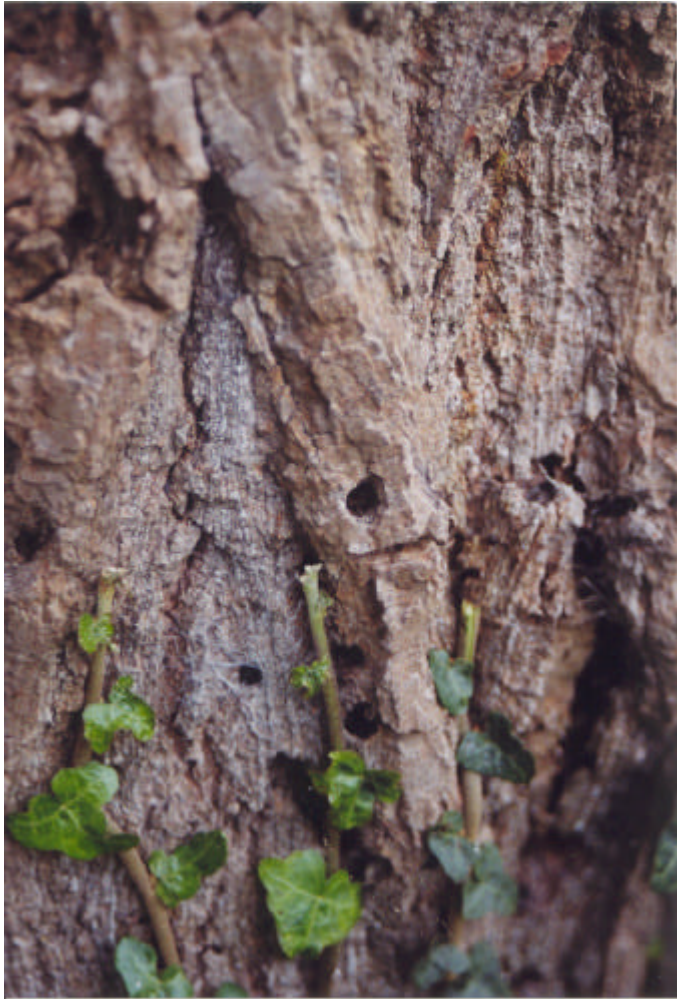
The base of most trunks where not obscured by dense ivy growths, was attacked by wood boring insects, probably Hornet Clearwing Moth *Sesia apiformis*. On some trees, these attacks appeared to be with a quite high density judging by the regular holes in the bark (See photograph No 5). These borings appeared on the lower part of the trees and on some extended to about 1.5 high. The extent of activity was difficult to see on many trees because of the strong ivy growth. There is a paucity of information on these moths and whether the attacks occurred because of low tree vigour or were a cause of low vigour has not been demonstrated.

**Photograph No 5**  
Bore hole activity of Hornet Clear Wing  
Moth

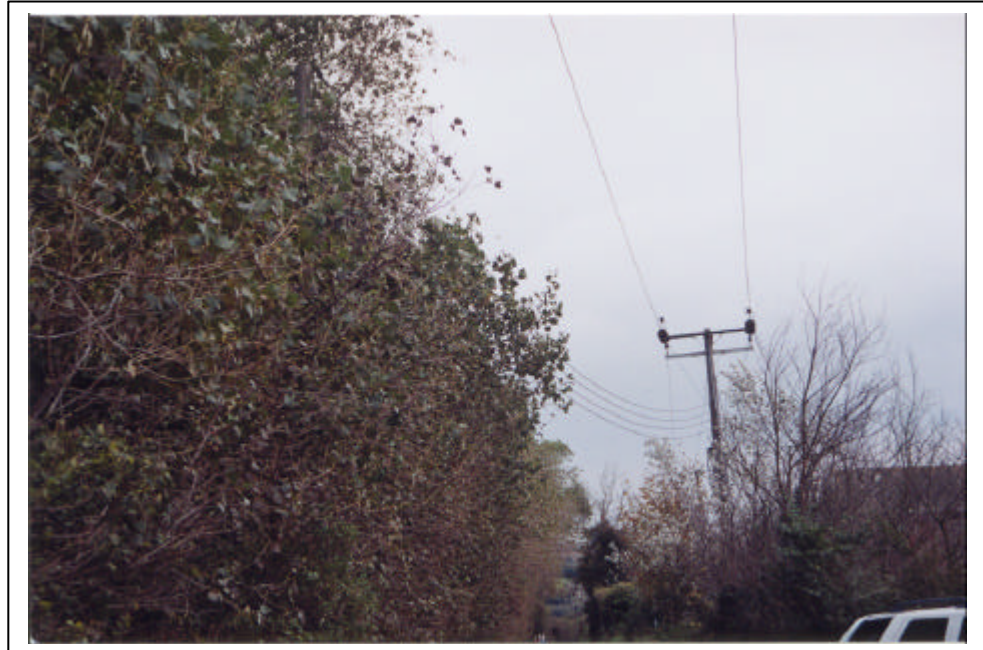
At 61m from the south end, the next poplar tree had been lopped at about 6m from ground level being immediately below the overhead lines. Covering ivy was very vigorous. This tree and the rest of the row all appeared healthy despite the lopping (See photograph No 6).

**Photograph No 6**  
Healthy growth of trees in West  
section

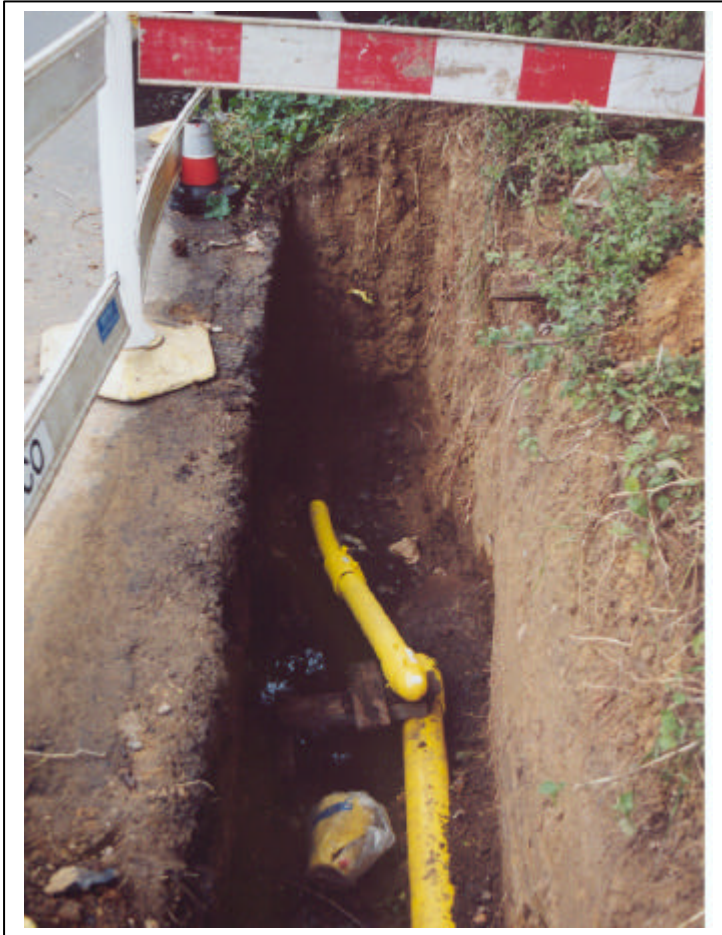
Soil Profile 1 in the lower trench(Photograph No 7)

Profile below healthy poplar tree with elm scrub between tree and soil face.

The soils are generally well drained and coarse loamy throughout.

A sample of soil was also taken from the undisturbed base of the trench adjacent to and from under the gas pipe. This was sent for an Atterberg test to ascertain its plasticity and the probability of tree roots causing subsidence damage to the gas pipe. The sample was confirmed as none plastic and therefore the roots would not cause subsidence damage. See Appendix A

There were no large (over 25mm) tree roots seen in walls of the trench although the pipe was surrounded by small fibrous roots, samples of these were sent for identification and were confirmed as emanating from poplar trees. See Appendix A

Trees adjacent to these soil profiles appeared to be in good health and the soil conditions were well drained and base rich and appeared to be well suited to poplar trees. Wind exposure was on the high side for poplars, but these trees were generally very vigorous in their growth pattern and exposure to high winds off the Thames Estuary appeared not to limit growth.

**Photograph No 7**  
Lower trench from which soil and root samples were taken.

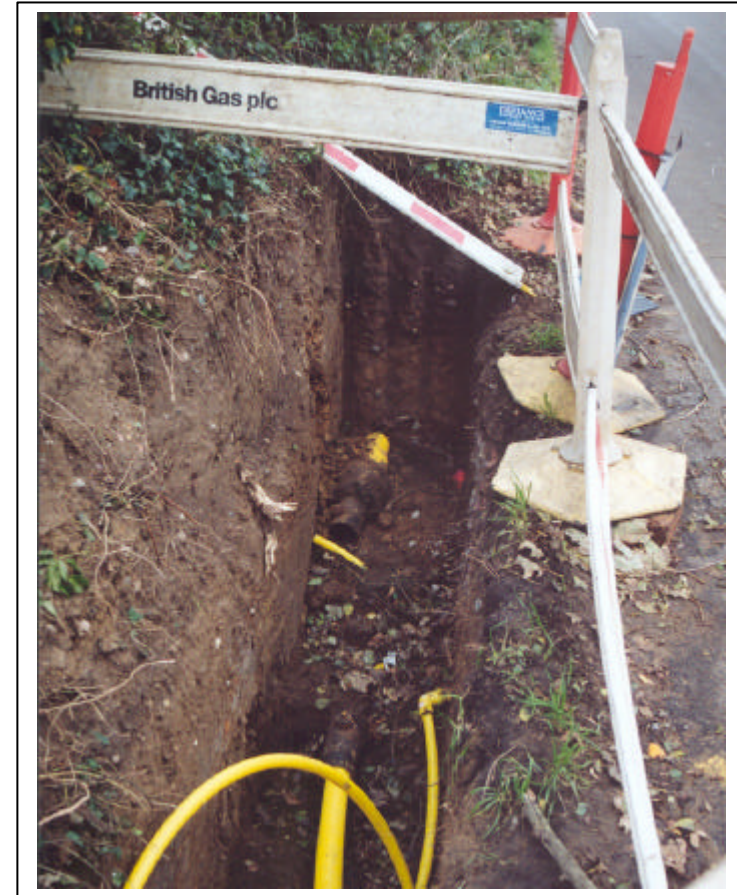
Soil Profile 2 in the upper trench (Photograph No 8)

Profile below healthy poplar tree with ivy and stinging nettle.  
Described from side of exposed trench and therefore the soil is partly dried out.  
Parent material is loamy Head.

Soil is affected by slight seasonal waterlogging below about 75cm depth and has coarse loamy over fine loamy. Part of the exposed profile may be fill from earlier trench backfilling.

A sample of soil was also taken from the undisturbed base of the trench adjacent to and from under the gas pipe. This was sent for an Atterberg test to ascertain its plasticity and the probability of tree roots causing subsidence damage to the gas pipe. The sample was confirmed as being of low plasticity and therefore the roots would not cause subsidence damage. See Appendix A

There were no large (over 25mm) tree roots seen in walls of the trench although the pipe was surrounded by small fibrous roots, samples of these were sent for identification and were confirmed as emanating from poplar trees. See Appendix A

**Photograph No 8**  
Upper trench from which soil and root samples were taken.

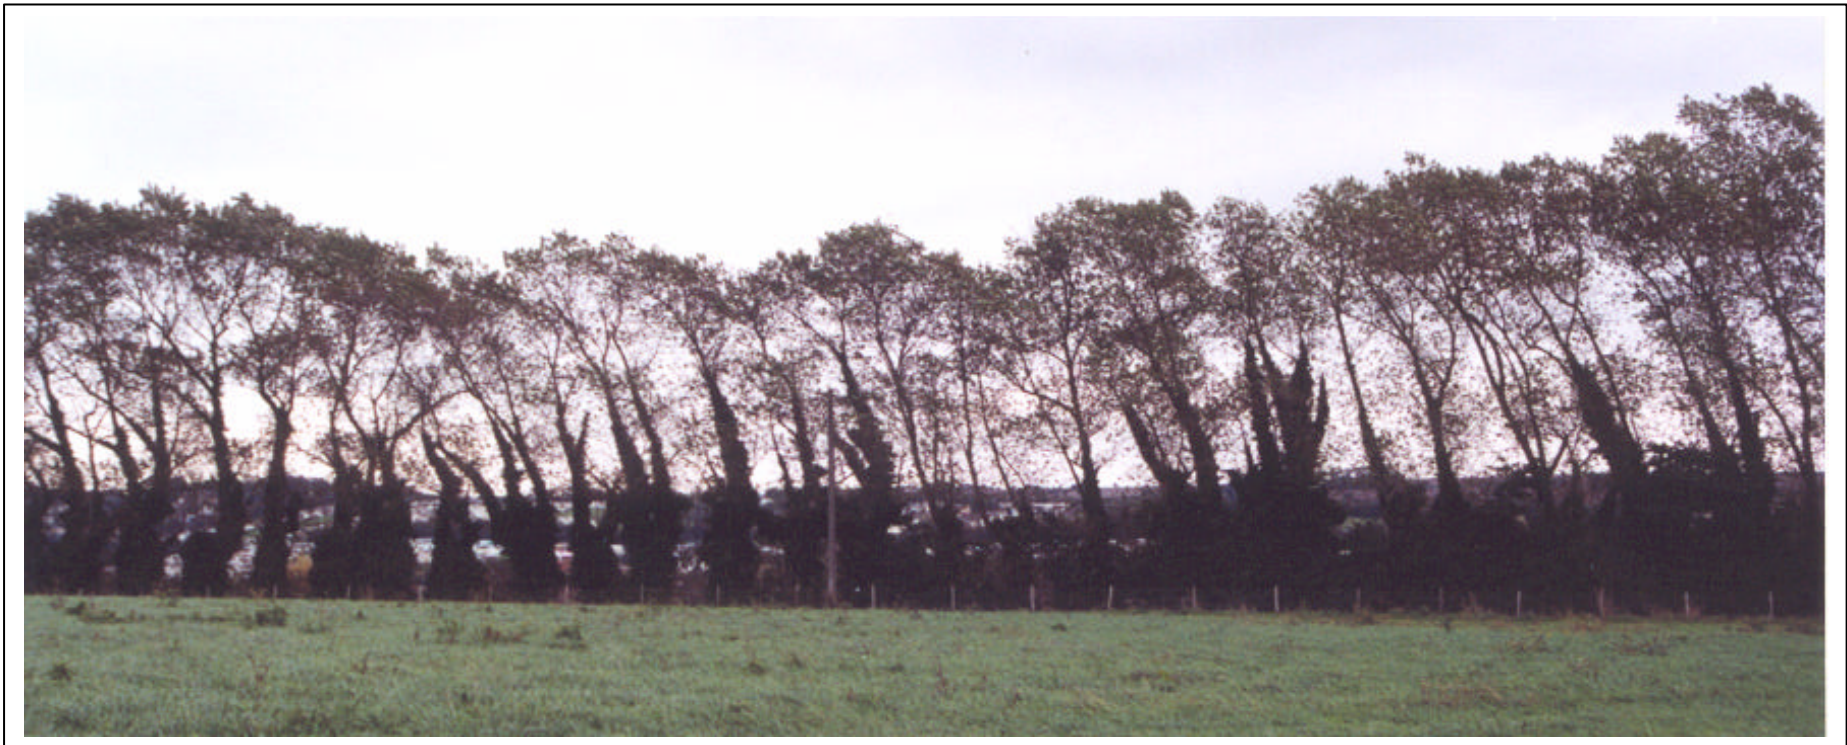
The owners of the adjacent farm, reported weak thin crowns of this row of trees when compared to the row of trees adjacent to the farm entrance track (See photograph 9). The weak thin crowns were probably the result of the lopping of branches below overhead lines. Other factors that may have affected the roadside trees and contributed to the thin crown effect and not the "control" trees include salt treatments to the road and soil cultivations over the root zone.

**Photograph No 9**  
Row of trees adjacent to farm track
